Ethan Residence

Lake Winnipeg, Manitoba

Shoreline Stabilization Projects

Manitoba, Canada; 2006 – 2007

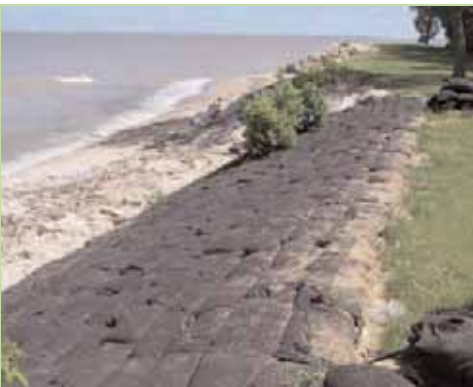
Village of Dunnottar - Municipal Park

Shoreline Envirolok mattress wall

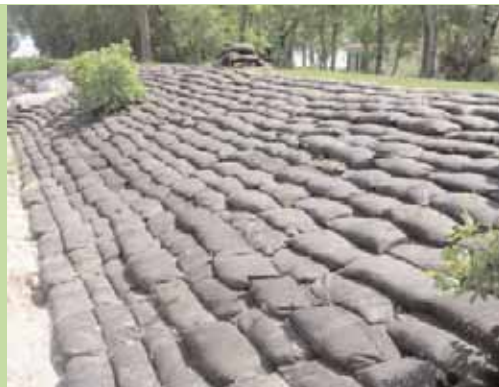
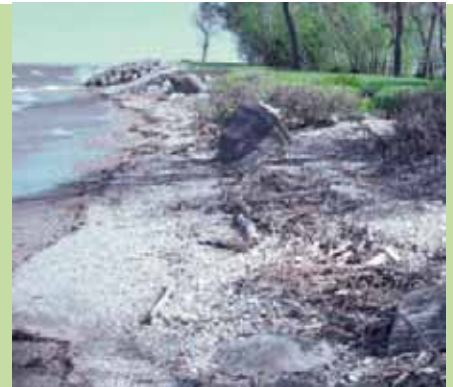
Before

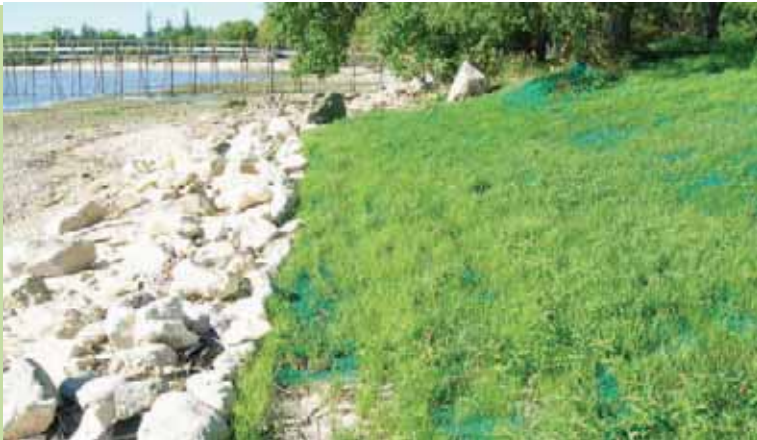
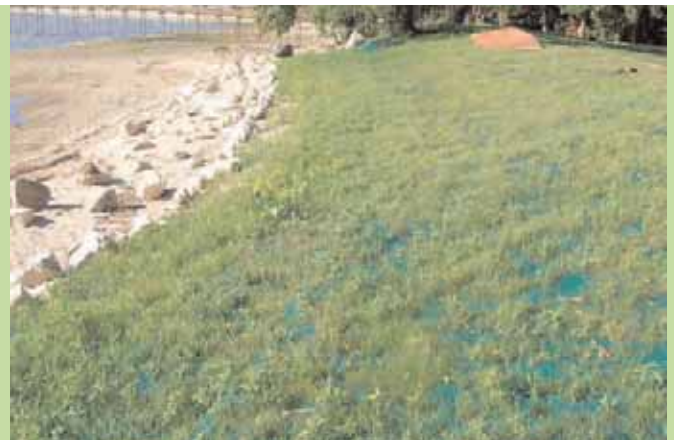
Ethan Residence

New vegetation; sixty days from planting

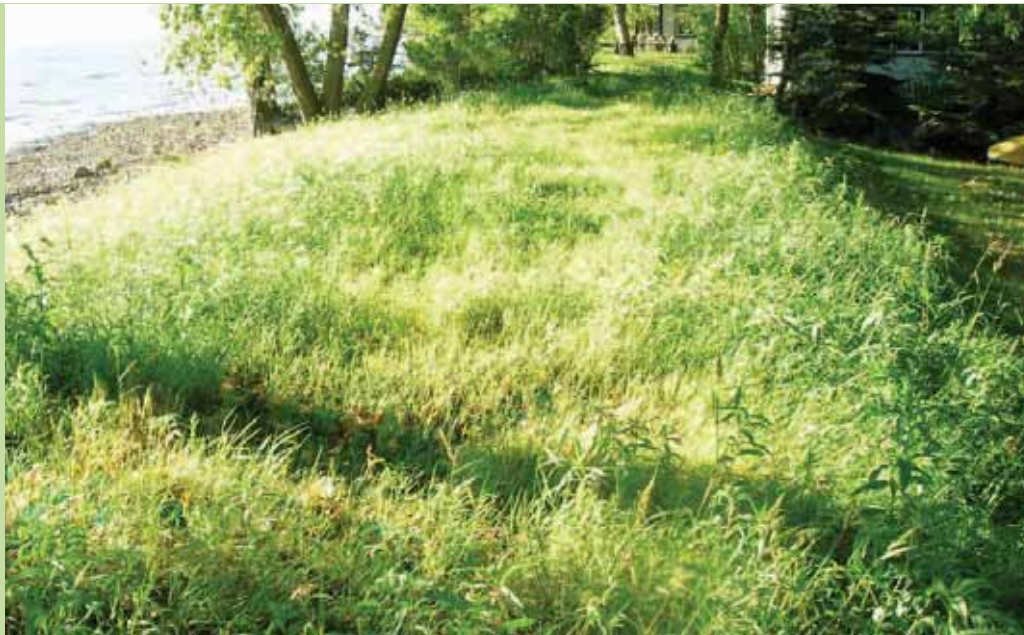
Morris Residence

New vegetation; sixty days from planting

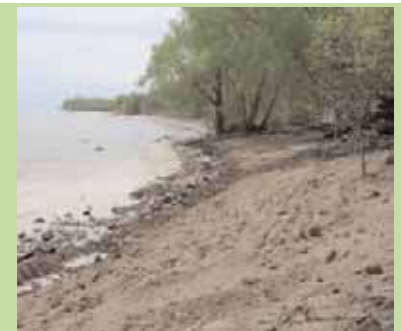
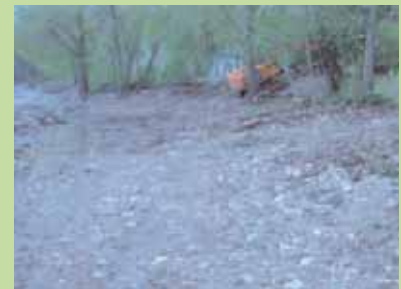
Before

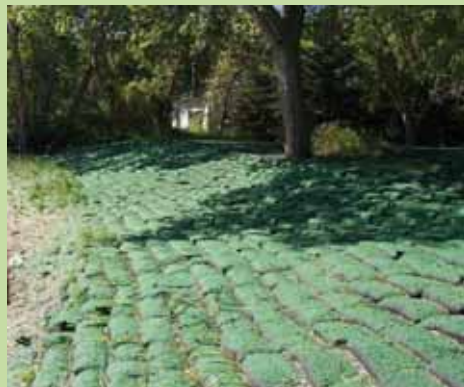
Hydroseeded

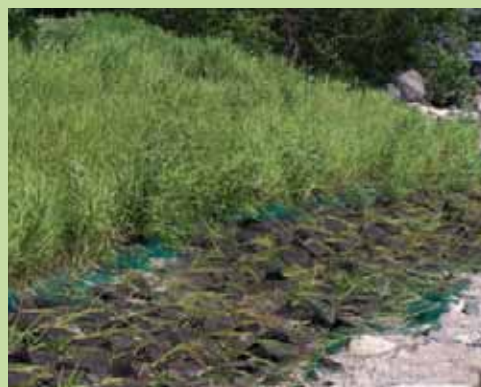
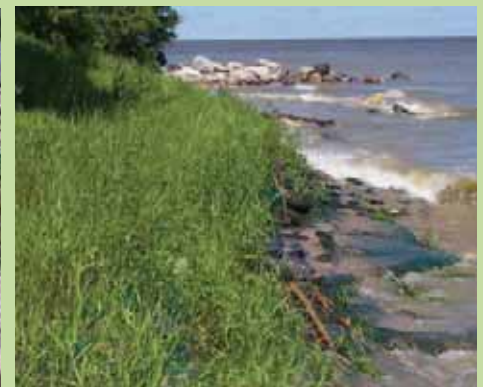
New vegetation
